CHARACTERISTICS OF LABOR ACCIDENTS CAUSED BY SLOPE FAILURE DURING SLOPE CUTTING WORKS AND APPLICATION OF TILT SENSOR FOR MEASUREMENT OF SLOPE MOVEMENT

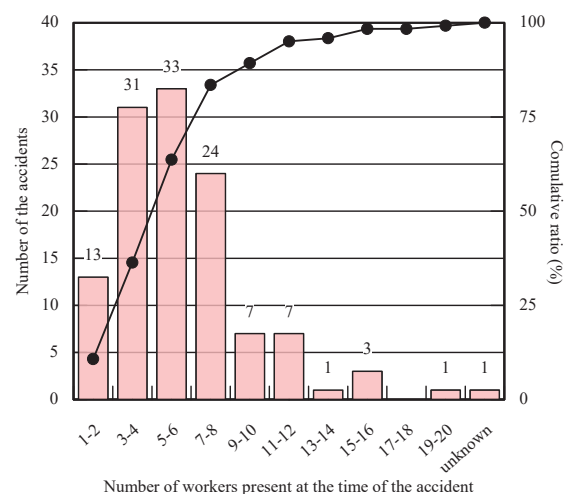
Figure 2 shows the relationship between the number of accidents and that of the workers presented at the time of the accident by bar graph, and a cumulative relative frequency of number of the accidents by line graph. This figure estimated that 84% of the accidents occurred in the construction projects with less than 8 workers on the construction sites. Since the number of workers can be related to the size of the contractor, the accident rate also corresponds to it as well and the possibility of accidents is higher with small-middle-sized contractor. This is probably due to the facts that the small-middle-sized contractors have problems of not only shortage of operation chiefs and/or workers with appropriate knowledge concerning safety and health management but also shortage of budgets for adequate safety equipment. Based on these findings, it can be concluded that the labor accidents are likely to occur in the small-middle-sized construction projects with small budgets and relatively short construction period conducted by the small-middle-sized contractors.

Figure 2 Number of workers present at the time of accident [4]

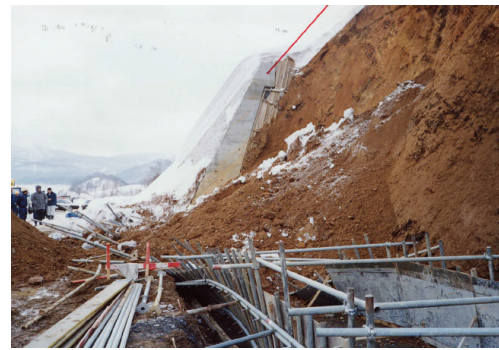
Figure 4 Accident site at concrete frame construction work [7]

There are mainly two slope stabilizing construction methods which cause slope failure accidents: retaining wall method and slope protection method as shown in Figure 3. According to the investigation conducted by Itoh et al. [4], approximately 73% of the labor accidents occurred during slope stabilization construction works by the retaining wall method. In contrast, the number of accidents that occurred during works using the slope protection method was much smaller (approximately 16%). This is probably caused by the facts that the retaining wall construction generally includes the excavation of steep and unstable slope (Figure 4, [7]),

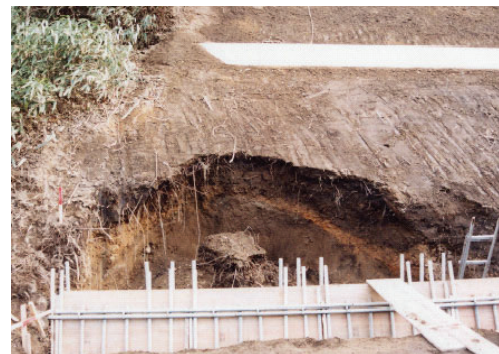
Figure 5 Accident site at frame dismantling work [7]

and various construction works such as assembling/dismantling of formworks (Figure 5, [7]), smoothing of base and so on have to be carried out in a narrow space between the retaining wall and the excavated ground. Therefore, it is too difficult and too little time for workers to evacuate from such narrow working space when slope failure suddenly occurs.

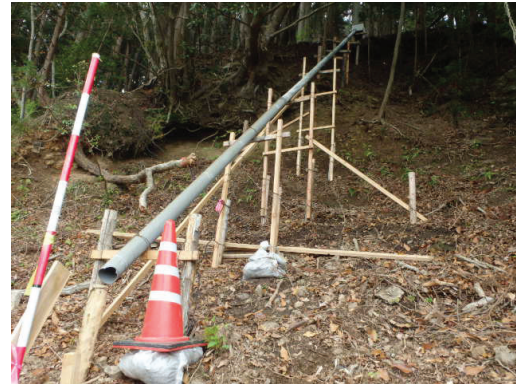
The site, shown in Figure 6, located in Shizuoka Prefecture, Japan, was for the project of restoration works for the road damages and the slope failure caused by the heavy rain in 2018. A top-down slope stabilization method was used for the project, which is one of the effective construction methods to prevent the possibility of slope failure and protection materials for the method are short reinforcing steel bars and shotcrete which can be obtained at lower costs than those for the ground anchor method.

Figure 6 installation of this site

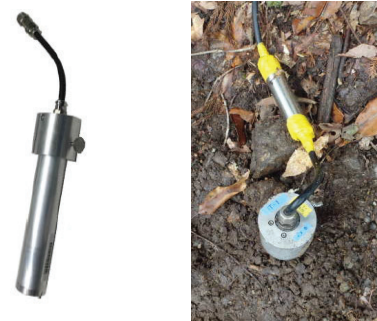
Figure 7 IT tilt sensor (AKEBONO Brake Industry Co., Ltd)

Two types of measuring instruments were used for the project: one wire extensometer and two high precision tilt sensors. A wire extensometer (sensitivity of 0.1mm, SLG-100A, OSASI Technos Inc.) was used to measure the deformation of slope surface. A high precision tilt sensor (IT tilt sensor, AKEBONO Brake Industry Co., Ltd) was equipped with a MEMS tilt sensor as shown in Figure 7. This is used to measure positive and negative angles in both X and Y directions angles. Its measuring range was ± 20 degrees with sensitivity of 1/100 degrees. The tilt sensors were placed along the cross section of the site and installed on the single pipes mounted in the holes made by hand augering to a depth of 0.5m. The data logger, powered by three double A (AA) battery, recorded the data at 1 min interval.

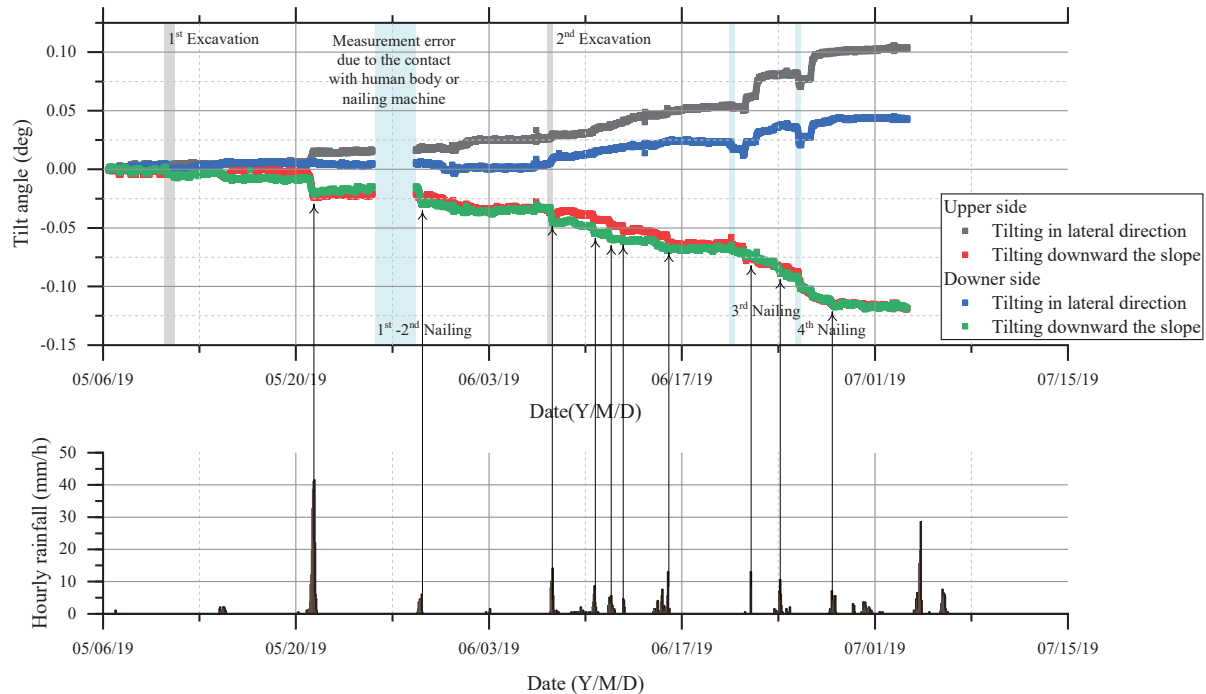
Figure 8 Time history of two tilt sensors and records of rainfall

A wire extensometer did not record a slope movement during the construction. Figure 8 shows the time history of two tilt sensors including some main events: excavation, nailing, rainfall, etc. Figure 9 shows the photos during and before the construction in this field monitoring site. Movements of X and Y directions were measured by each sensor. A quick tilting in the X and Y directions were recorded on May 21 when the precipitation was 236.5mm. Related to some events such as excavation and nailing (slope protection), gradual change was observed in the tilting angles. Direction of slope movement during various events could be measured by observing the very little movement: sensitivity of 1/100 degrees of tilt sensors along X and Y directions.

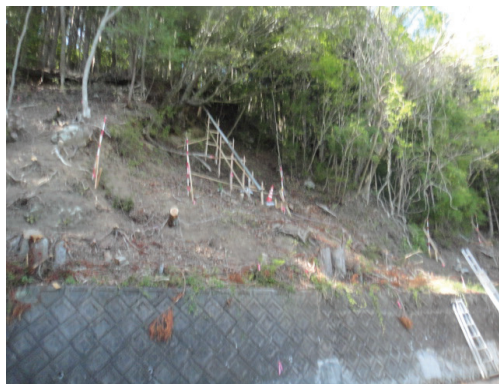
Figure 9 Excavation and nailing phases during this construction
